Advanced Composite Tail Rotor

For the Bell-47 Helicopters and Its derivatives Equipped with
Bell 47-641-170 hub, and Bell 47-640-075 gear box.

Installation and Maintenance Manual

Part Number HAC-47-3

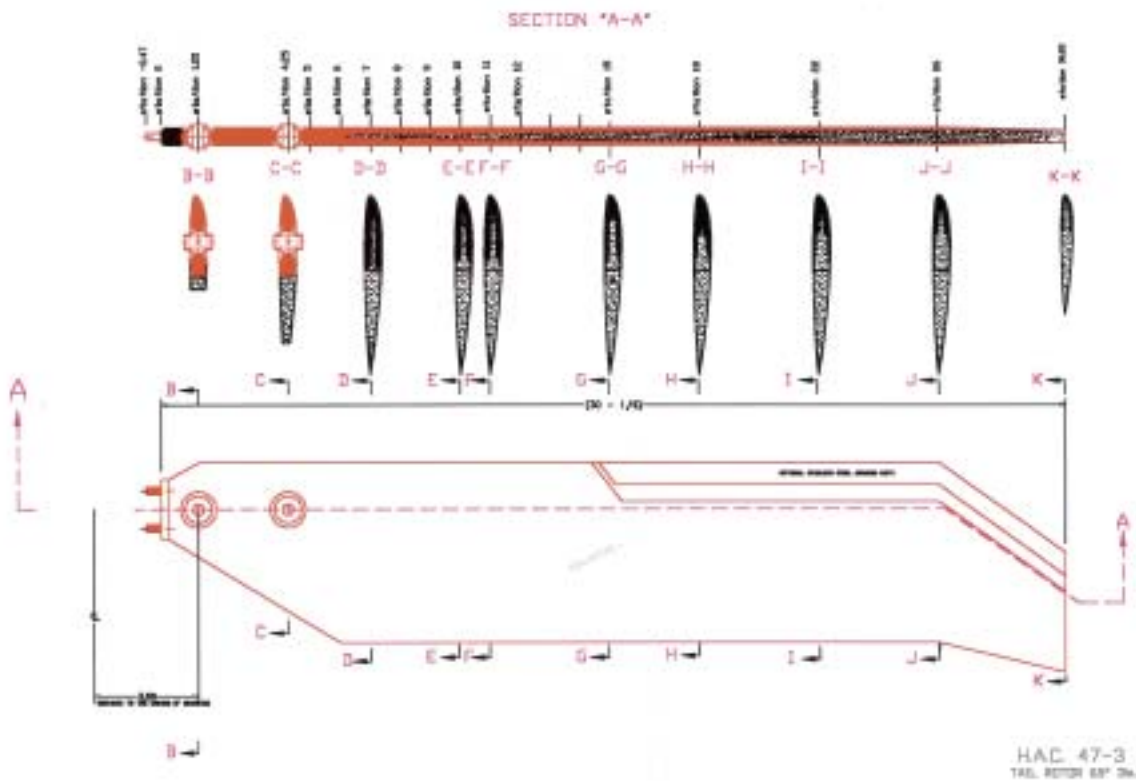
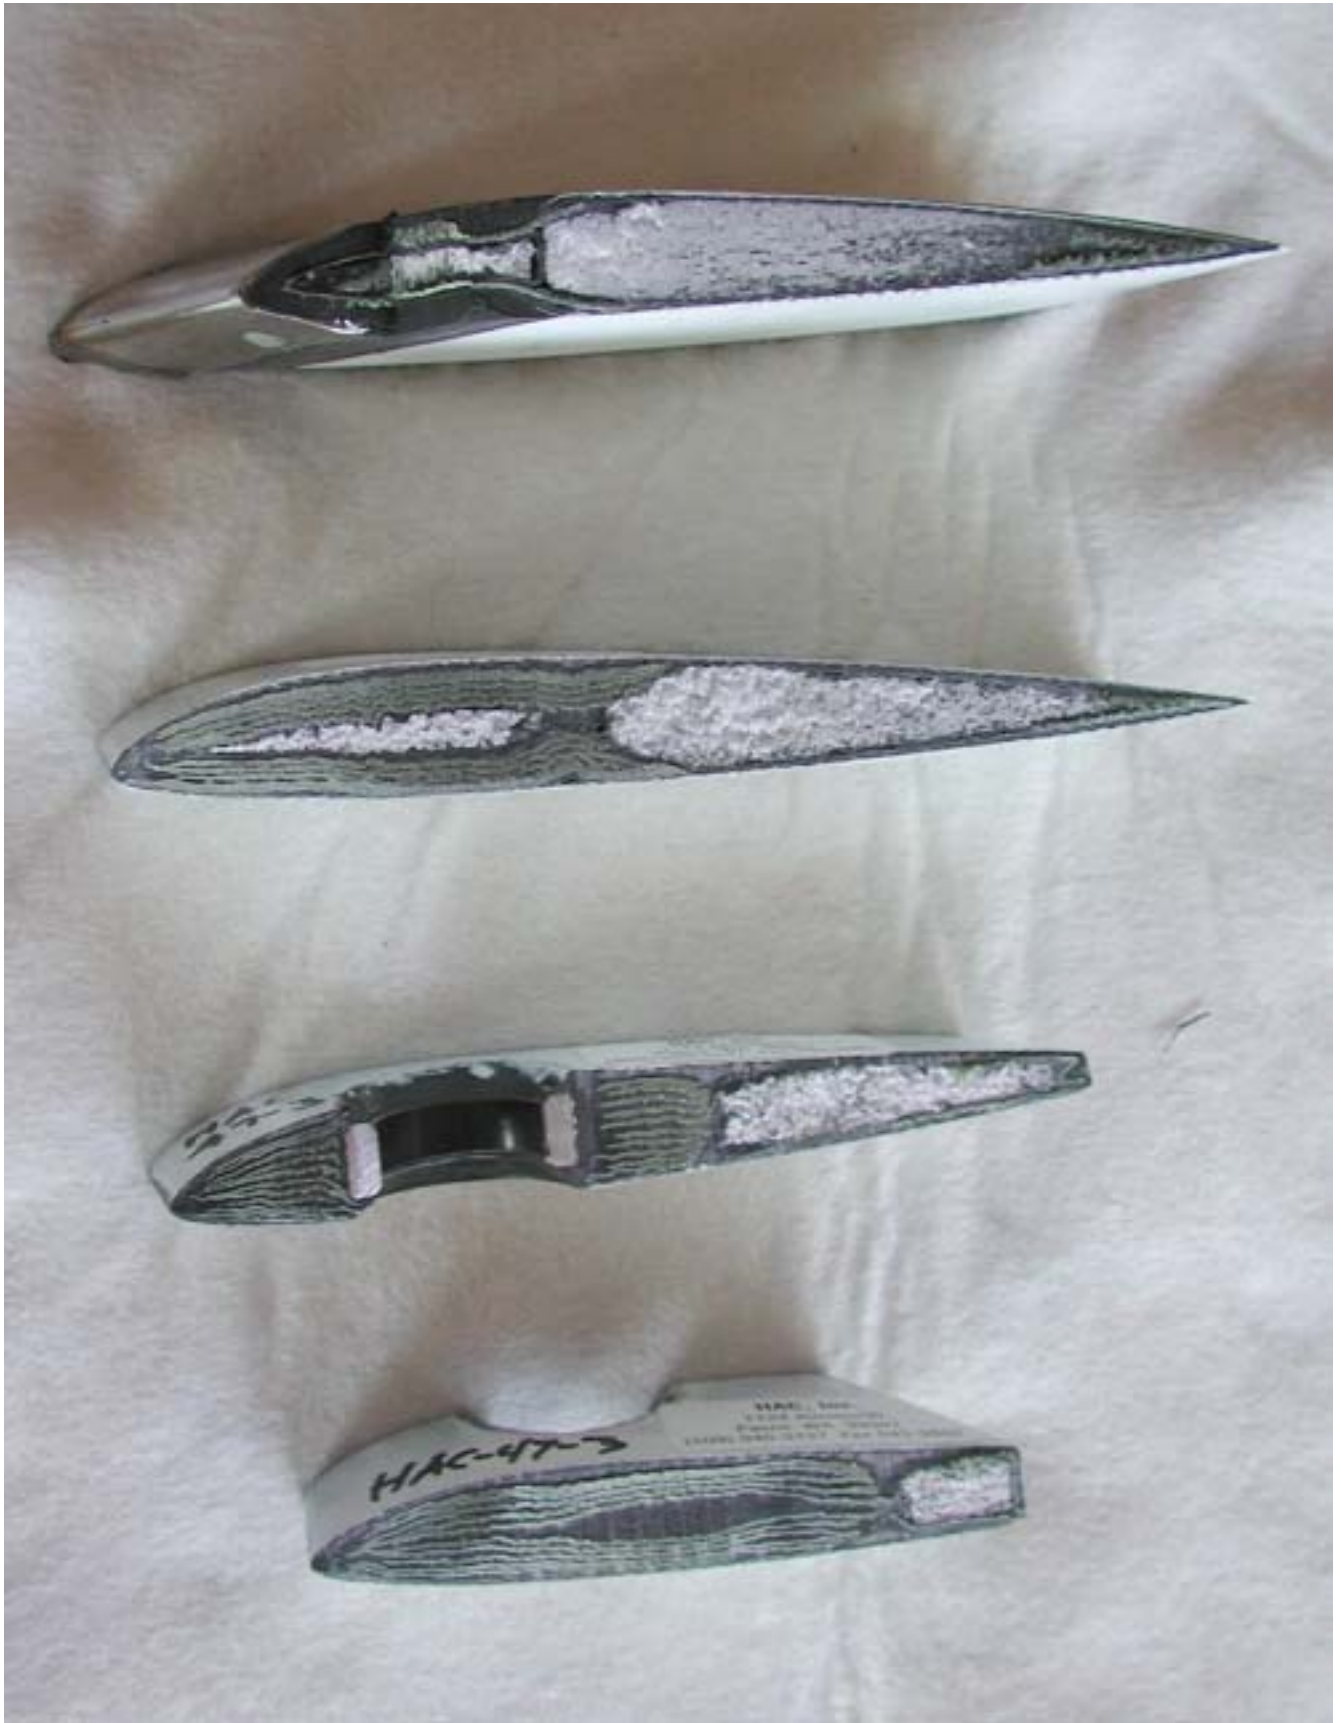
As shown in the drawing below, the internal structure tapers toward the tip of the blade.

The primary structure is located in the first 35% chord of the airfoil and is under the lightning protection screen and is not repairable.

In these cross-sections the variation of the primary structure is clearly visible as are the carbon And aramid, (Kevlar), layers.

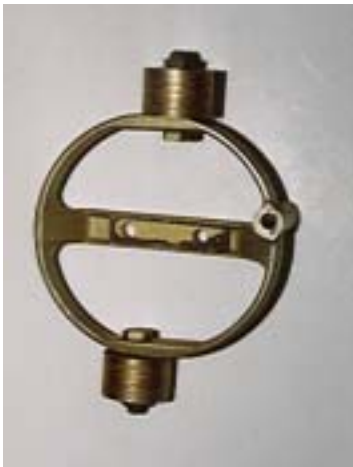
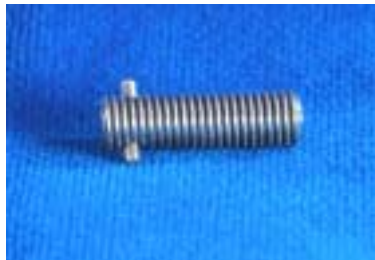
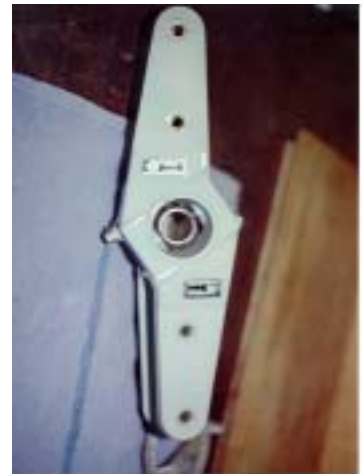
Hub assembly, Bell part number 047-641-170, shown below (right).

Pitch-horn retention stud assembly showing the “anti rotation pins” shown in center.

During pitch-horn ring installation care must be taken not to over-torque the pitch-horn ring Retention nuts. Torque-wrench of no greater capacity than 250 lb-in – 28.5 N*M should be used and the nuts should be torqued to only 36 Lb-in, (3.00 lb-ft = 4N*M). Larger torque-wrenches are not accurate enough at this low setting and may cause ‘over-torqueing’ the nuts shearing the ‘anti rotation pins’ and pulling out the studs. After torqueing safety wire nuts.

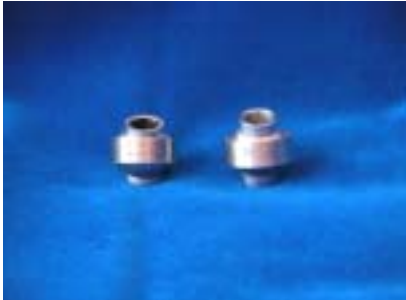
Tail rotor blade, HAC part number HAC-47-3, shown below.

The leading edge abrasion strip may be replaced by any qualified and HAC Inc trained person using HAC supplied materials, tooling, and procedures.

The two bushings may be replaced by any qualified and HAC Inc trained person using HAC supplied materials, tooling, and procedures.

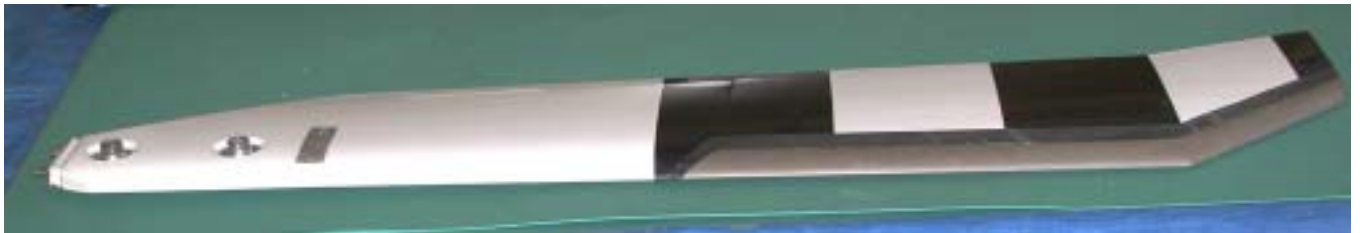
The blade is equipped with two replaceable HAC-SSWF ball bushings. Drawing Number: HAC-075-0003.

These bushings provide +/- 23° of maximum pitch movement.

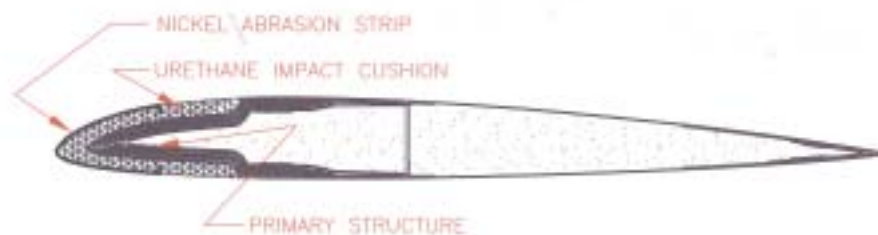
The HAC-47-3 Blade with the Nickel abrasion strip.

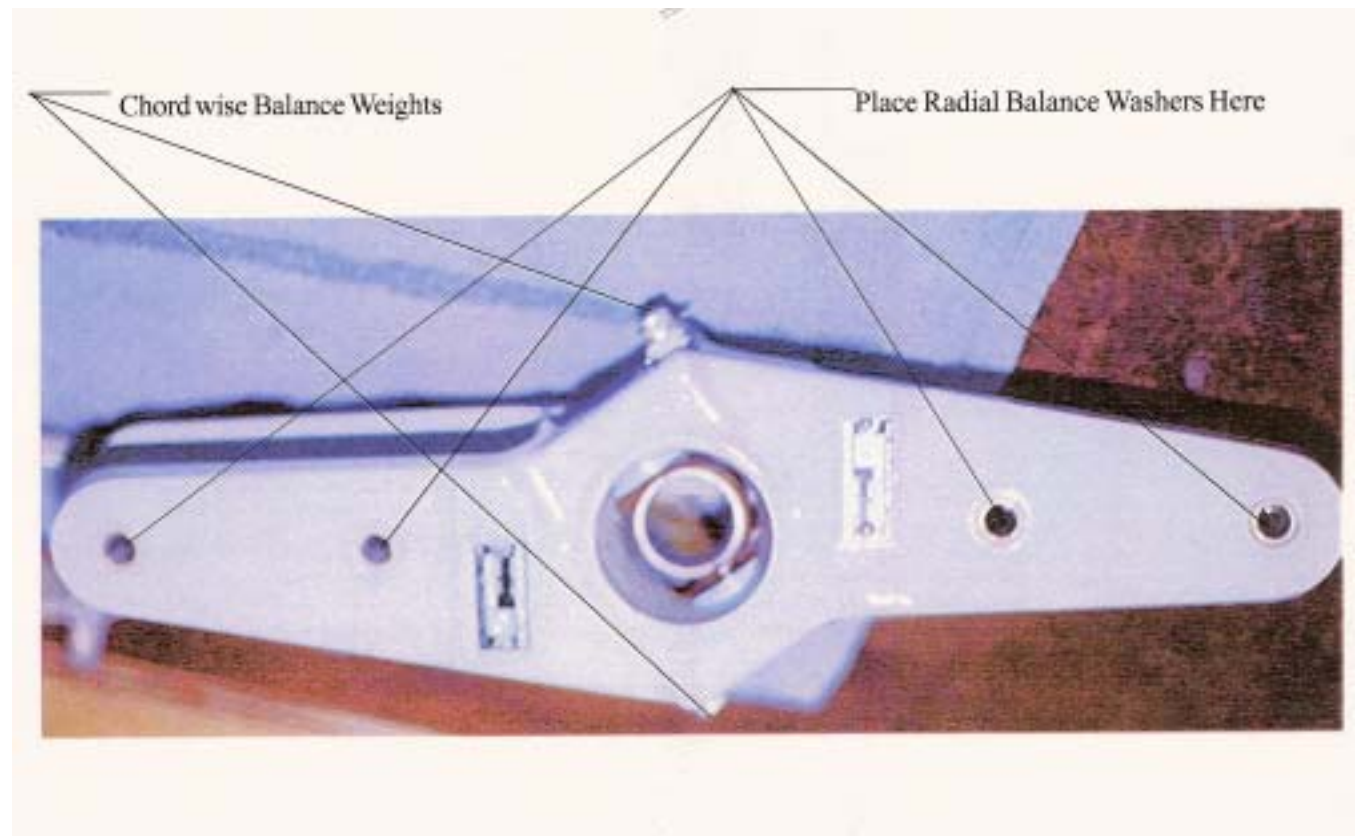
The pitch-horn ring, blade, and hub assembly should be statically pre-balanced. Either of the two standard Bell static balancing fixtures may be used. Attach balance weights, (washers), on the blade mounting bolts for radial balance and attach weights to the hub for chord wise balance as shown in picture below.

After installation final balancing should be accomplished using a 'Chadwick' or similar dynamic balancing system.

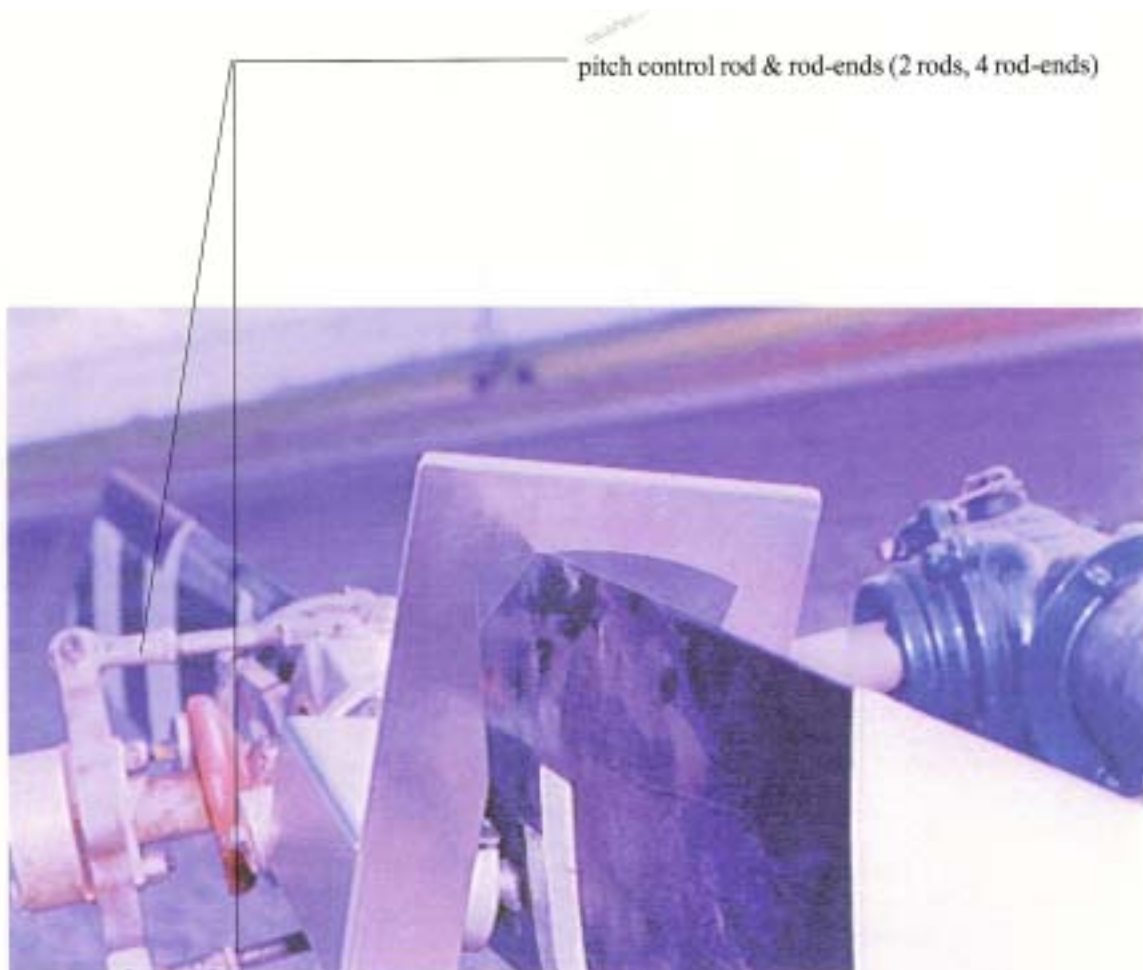
Tail rotor rigging for the HAC-3-47 blade is as follows: Turn the pitch control rod and rod-ends (see picture below) out until you see through the safety hole, then turn in one to two turns. This should give you 12 ½ to 15 degrees of travel in both directions. If you cannot achieve this travel see SECTION 4, Trouble Shooting.

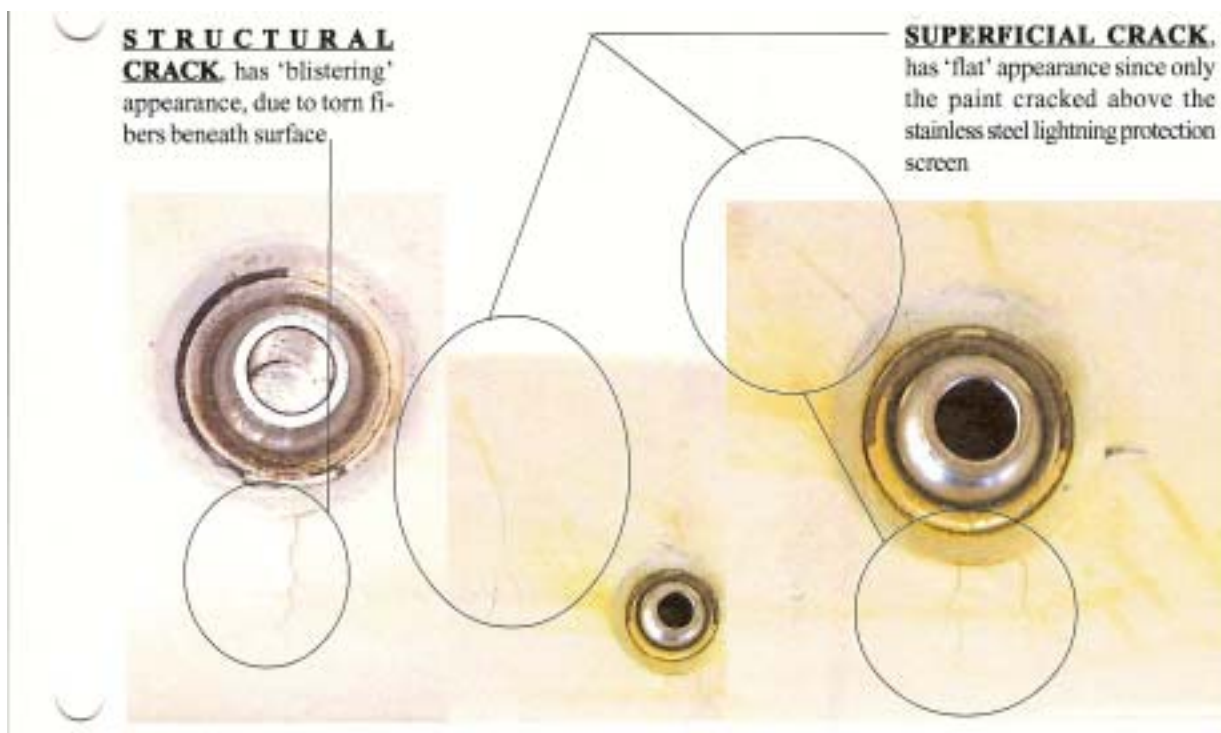
Note the structural crack is 'raised' and has a swelling appearance due to the torn fibers that are pulled out of place causing the swelled appearance while the superficial surface crack is flat and peel able.

1. Thoroughly inspect the blade visually for damage.
 - a. Visually inspect around each bushing cavity for cracks on both surfaces. (see photo)
No structural cracks permitted. If there is a structural crack, the blade is NOT AIRWORTHY.

- b. Inspect the rest of the blade for cracks. Superficial cracks, cracks that are in the brittle paint only, may be touched up. (see photo)
2. Inspect pitch horn ring attachment. It should be solid. No play is permitted!

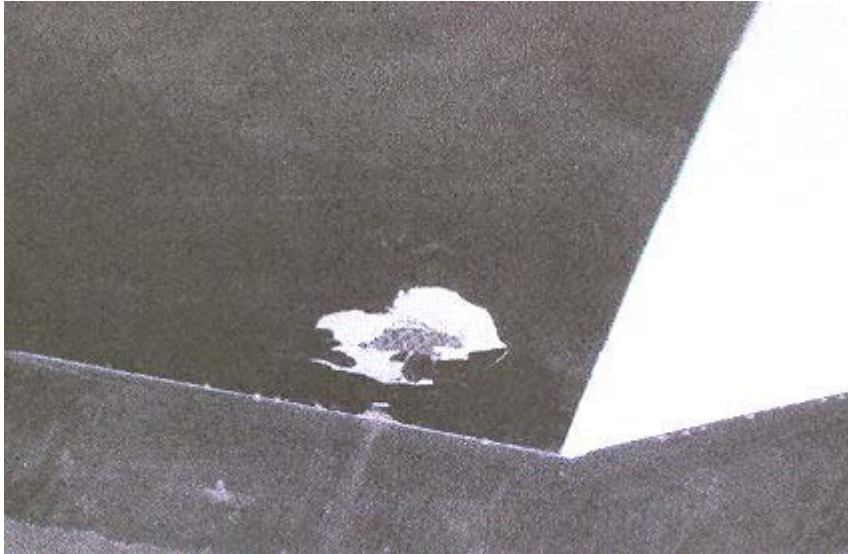
This superficial damage is down to the 'lightning protection' screen and is easily repairable.

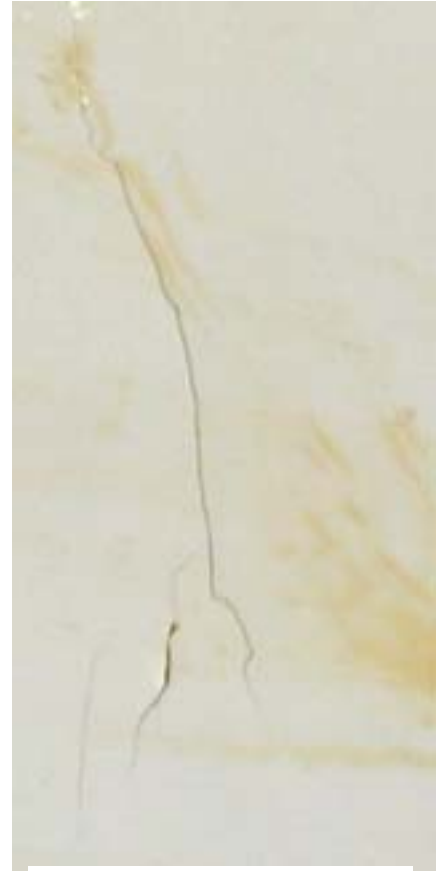
Another view of a superficial crack.

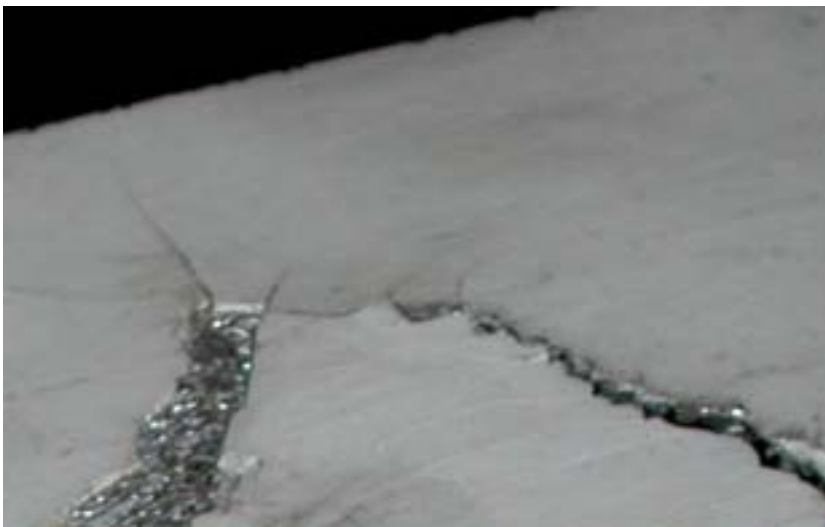
This is a picture of a major structural damage.

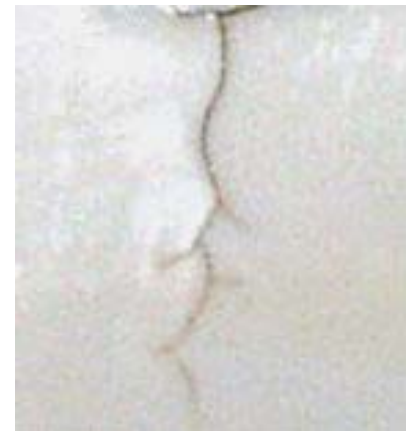
Swelling is clearly apparent in this picture of 'structural' damage

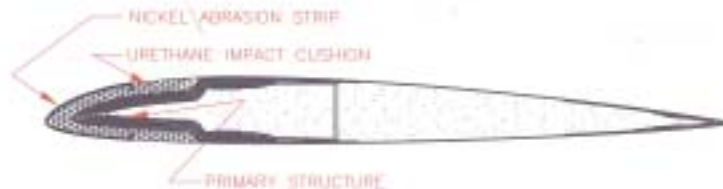
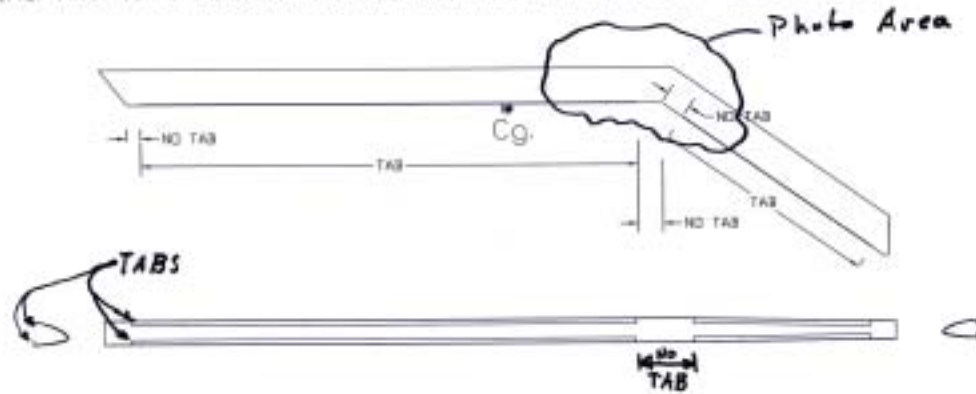
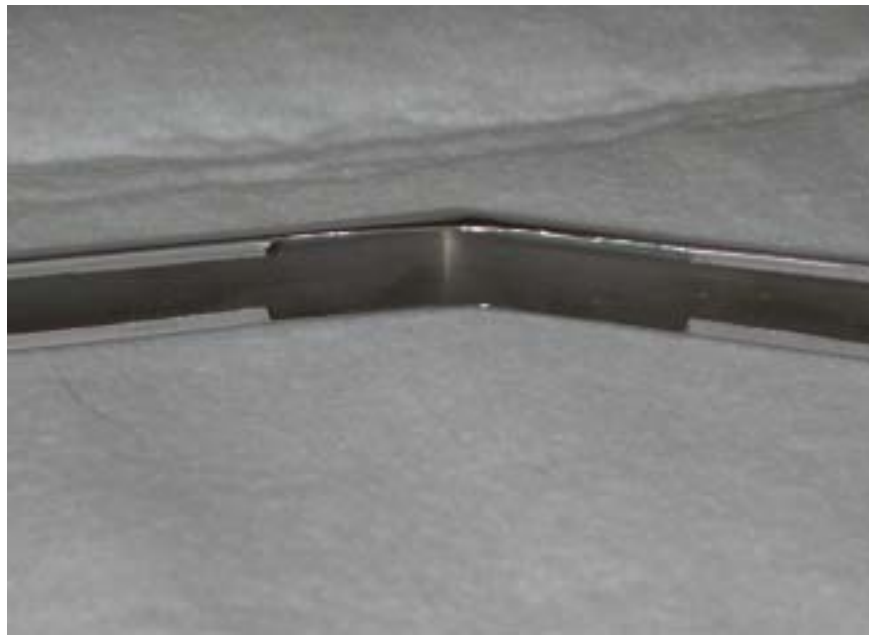
1. It has a 'tailored' cross-section that is 0.010" thickness at the leading edge that tapers to 0.005" at the trailing edge.
2. It eliminates the weld at the sweepback a very difficult procedure with high failure potential.
3. It offers a perfect airfoil in a complex shape. (The sweepback)

HAC solved this by a unique design in which there is a mechanical tab along most of the abrasion strip which mechanically fastens the abrasion strip. This tab also limits the relative movement between the urethane cushion and the nickel strip during impact and thus prevents shear of the glue during impact. Subsequently the nickel strip is held both by adhesion as well as mechanically.

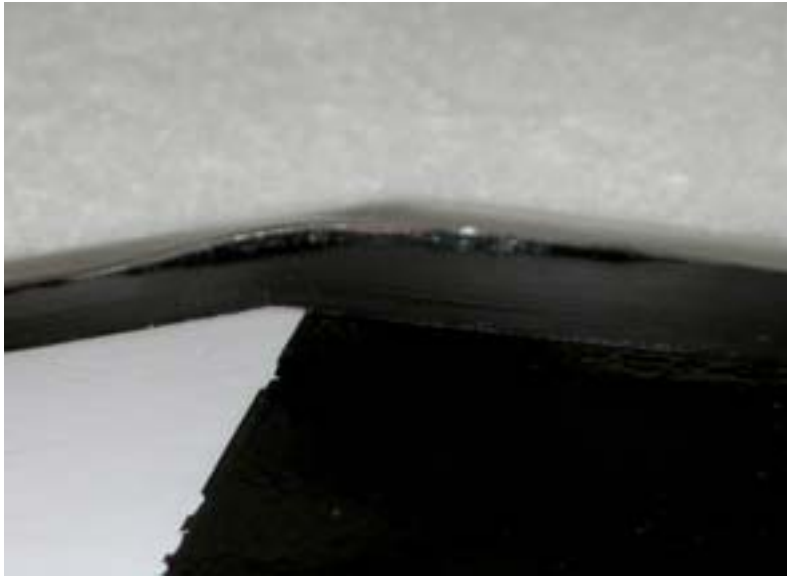
This separation does not diminish the integrity of the abrasion strip attachment nor does it appreciably affect the blade's aerodynamic performance but it is an ecstastic anomaly as can be seen in these picture below.

'Worst case' separation can be seen enlarged in this photo.

If the abrasion strip moved during the mold closure then due to the built up stress at the sweepback area is relieved breaking the glue line in the area 4 to 5 days after the beginning of the curing cycle. Where there is a vertical tab holding the nickel strip in place during curing the glue line is fully intact and functional.

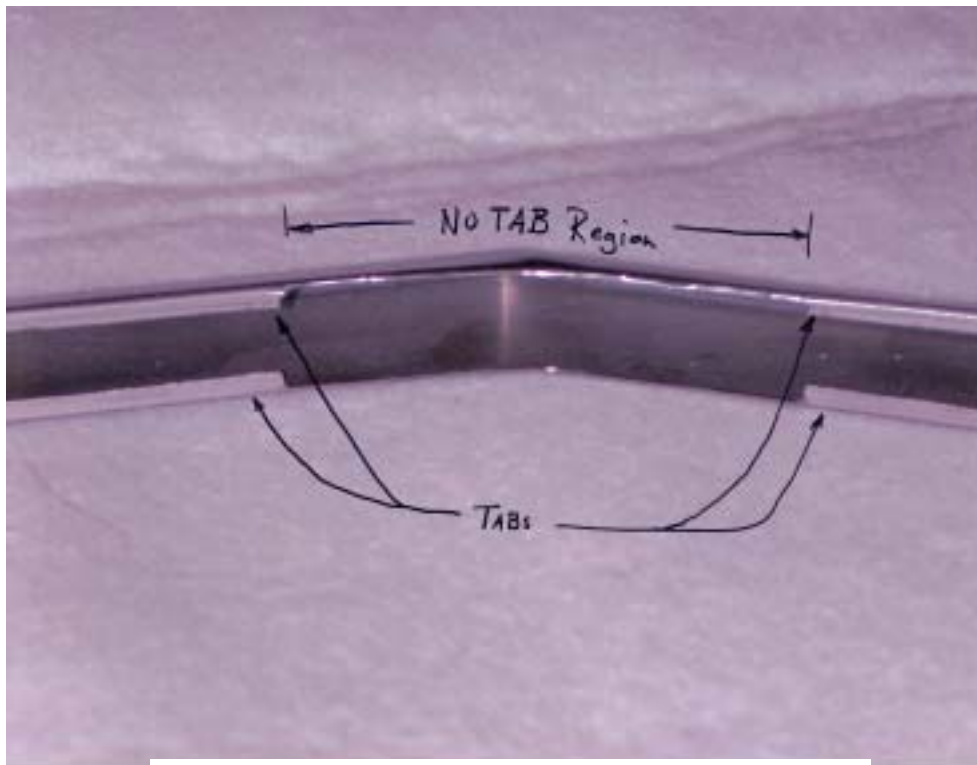
The affected area is clearly the 'tab' less area.
