Advanced Composite Tail Rotor

For the Bell-47 Helicopters and Its derivatives Equipped with
Bell 47-641-170 hub, and Bell 47-640-075 gear box.

Installation and Maintenance Manual

Part Number HAC-47-3

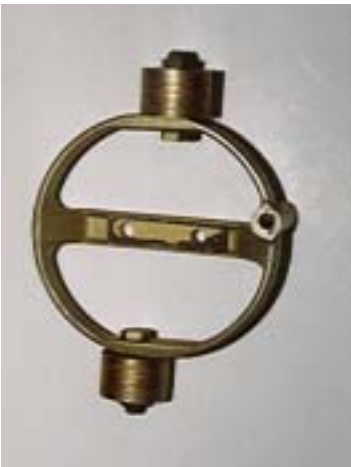
Pitch-horn ring assembly, Bell part number 047-641-187-007 shown below (left).

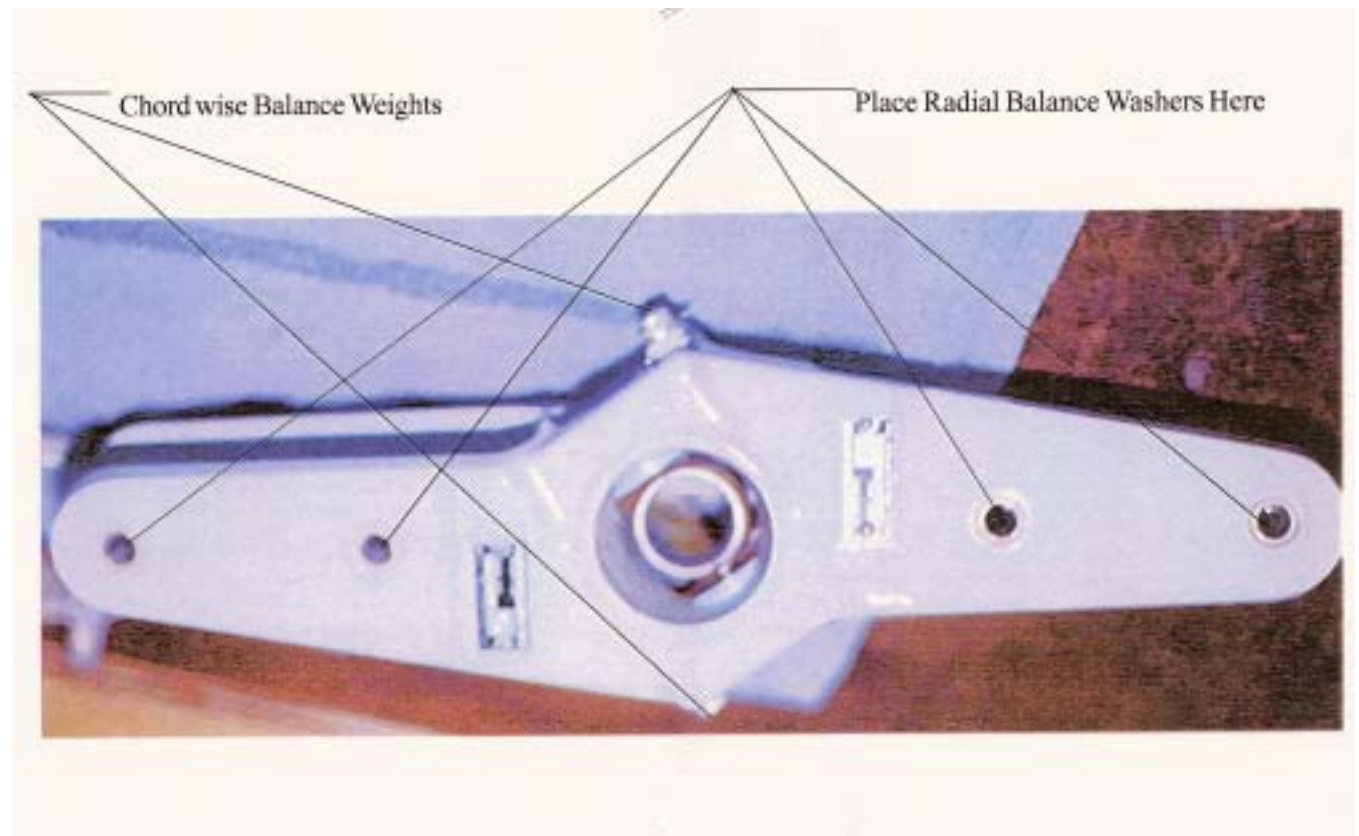
The pitch-horn ring, blade, and hub assembly should be statically pre-balanced. Either of the two standard Bell static balancing fixtures may be used. Attach balance weights, (washers), on the blade mounting bolts for radial balance and attach weights to the hub for chord wise balance as shown in picture below.

After installation final balancing should be accomplished using a 'Chadwick' or similar dynamic balancing system.

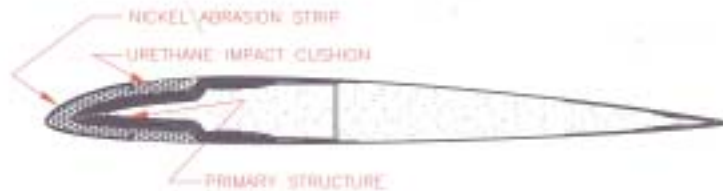
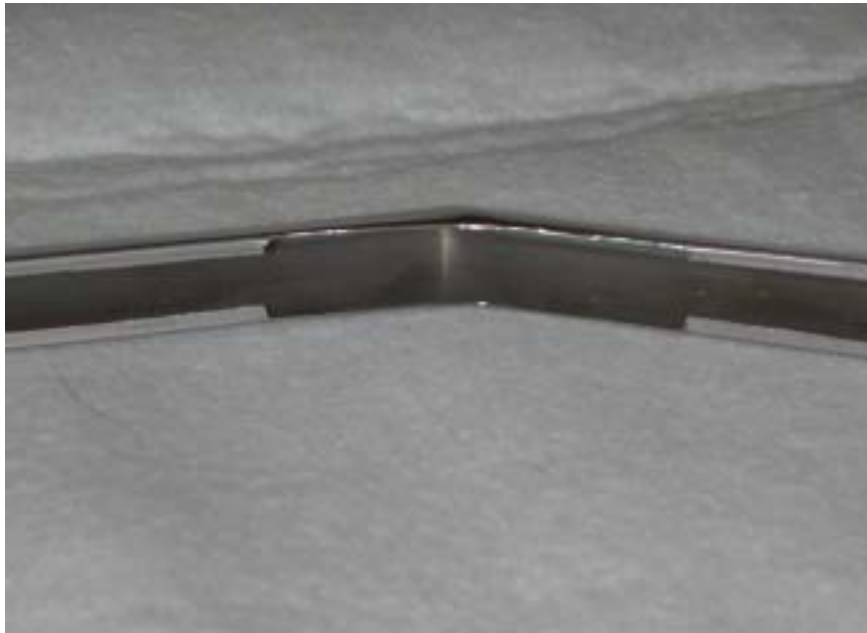
1. It has a 'tailored' cross-section that is 0.010" thickness at the leading edge that tapers to 0.005" at the trailing edge.
2. It eliminates the weld at the sweepback a very difficult procedure with high failure potential.
3. It offers a perfect airfoil in a complex shape. (The sweepback)

HAC solved this by a unique design in which there is a mechanical tab along most of the abrasion strip which mechanically fastens the abrasion strip. This tab also limits the relative movement between the urethane cushion and the nickel strip during impact and thus prevents shear of the glue during impact. Subsequently the nickel strip is held both by adhesion as well as mechanically.

To install the abrasion strip both the blade and the abrasion strip are primed and inserted into a mold. Unfortunately the nickel strip cannot be held accurately as the stainless steel, which was held on pins, which fit into the rivet holes, the nickel can “float” 0.005” to 0.010” when the mold is closed. The urethane impact cushion is then injected and “green” cured before the cuffed blade is removed from the mold. Unfortunately the urethane does not form a glue line until it is fully cured, (14 days), but then clean up and the ‘flash’ removal of the blade would be extremely difficult if not impossible.
